## APPLICATION OF PIPE WRAP REPAIR TAPE, UPS BRAND

Mining Company: Angloamerican.

Division: Los Bronces.

Date: September 5th, 2011

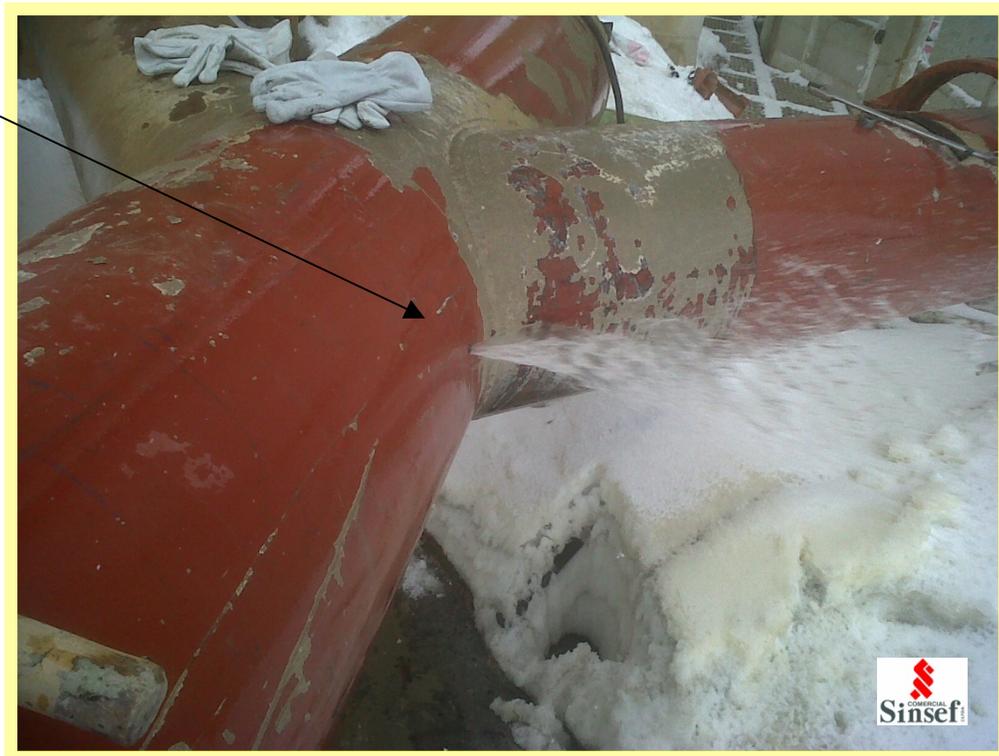
A rupture in the duct that supplies industrial water from the neutralizing tanks to the Grinding plant was detected.

Pipe diameter: 16"

Tank height: 8 meters (approx)

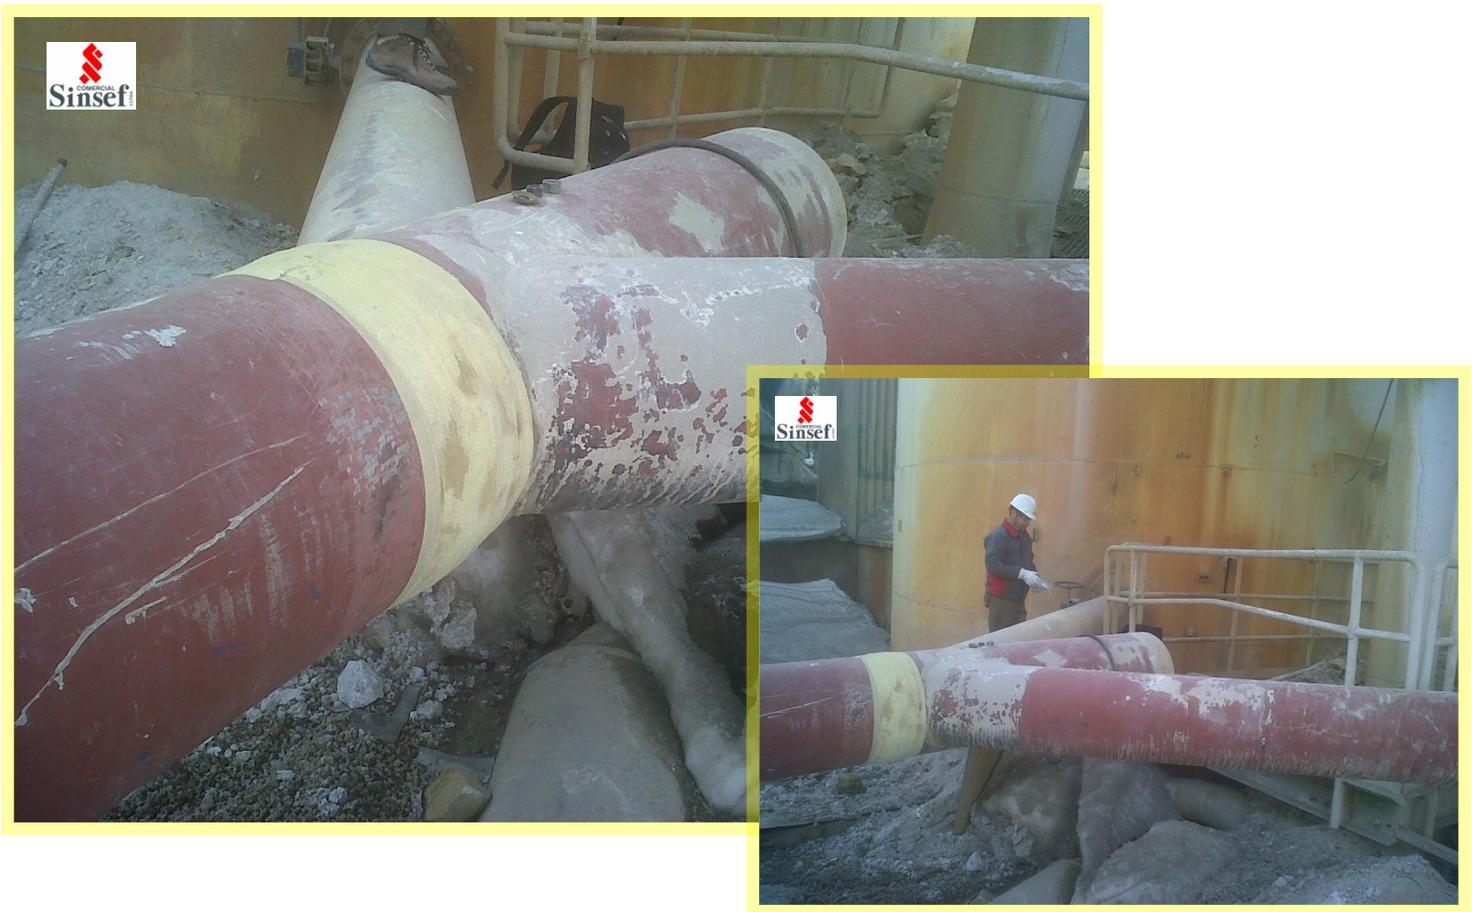
An immediate decrease in the flow is observed and a complete sealing is achieved after a few hours (around 2 hours at 20°C). It is likely that the curing time increases at lower temperature.

Along with the Angloamerican staff (Mr Edwin Castro and Mr Luis Moya) the affected area was repaired in field with ***“UPS Pipe wrap repair tape”*** and ***“UPS PlasSteel Twist Stick”***.

- 1.- The application took 30 minutes only.
- 2.- It was able to control immediately the water flow.
- 3.- The water supply to the plant was not stopped.
- 4.- The water pressure was lowered for only 3 minutes for the application of “UPS PlasSteel Twist Stick”.
- 5.- Finally the water leak was totally stopped.

- ✓ Mechanical clearing of the area around the rupture (sandpaper, wire brush or emery) is done with the purpose to improve the adherence of the pipe wrap repair tape.
- ✓ Protective rubber gloves are worn, the portion of product is cut from the stick and is hand mixed during 2 minutes approximately.
- ✓ The PlasSteel is applied in the rupture by making a kind of plug on the damage area.
- ✓ Then the pipe wrap repair tape is submerged under water for 20 seconds so that the hardening chemical reaction can start.
- ✓ The pipe wrap repair tape is applied as a bandage around the complete pipe perimeter by making an overlap exactly on the damaged area.
