UPS APPLICATION REPORT

A UK Unique Polymers applicator was awarded the contract to repair, rebuild and resurface the bow thrusters on a large RoRo ferry managed in the UK.

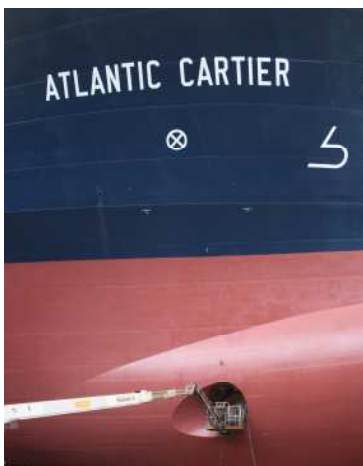
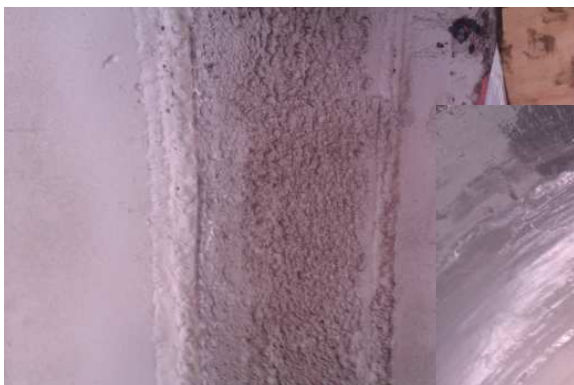
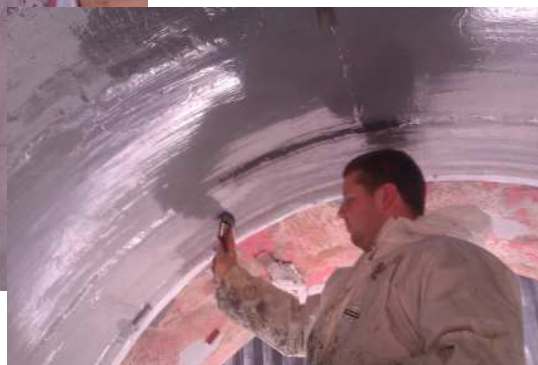
The vessel was suffering from severe cavitation attack on the liner situated in the bow thruster and the customer needed a long term hard wearing solution to ensure no further erosion and corrosion took place.

The surface of the steel liner was abrasive blast cleaned to SA2.5 50-75 micron profile

The surface was degreased using UPS cleaners

The pitting and scarring was filled by using 230 Ceramic Repair Paste

The repair paste was allowed to cure for 2-3hours, once it had initially set the protective coating was applied

2 coats of 235 Ceramic Repair Fluid (light grey and dark grey) were applied to the repaired surface

The coating was applied at a minimum 250-300 microns dft
