APPLICATION PROFILE UPS CERAMICS

UPS Specialist Applications has recently completed a project for a major UK ferry operator to refurbish one of the salt water filters on board a vessel.

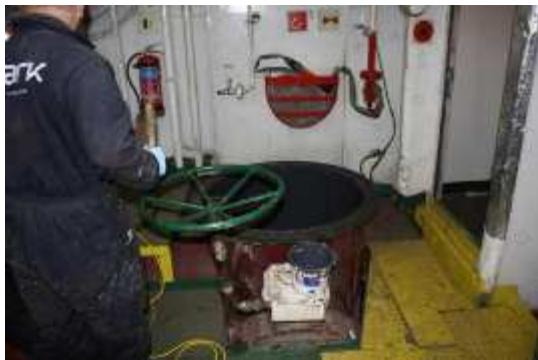
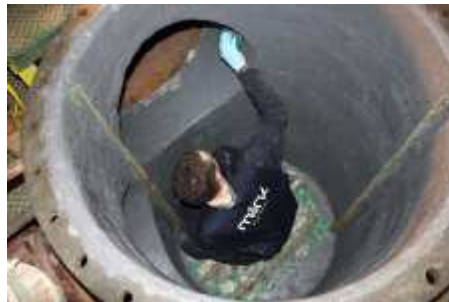
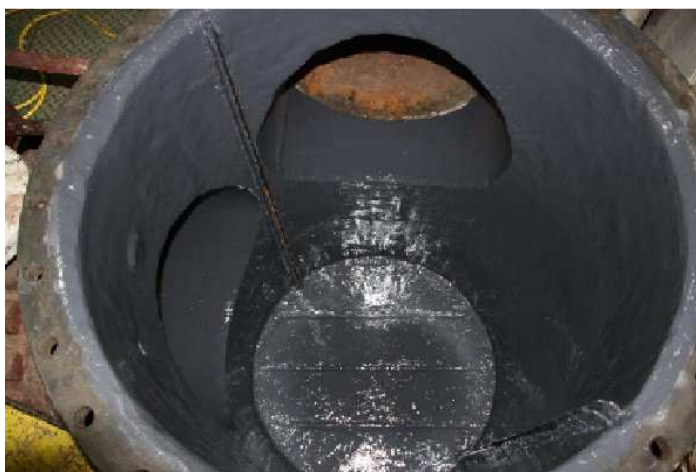
The internal surface of the filter was VacuBlasted to SA2.5 75 micron profile

To rebuild any heavily pitted or eroded surfaces a thin layer of 200 Ceramic Repair Paste was applied to the damaged surface

Once the material had initially set the first coat of 205 Ceramic Repair Fluid was applied

Another layer of 205 Ceramic Repair Fluid was applied once the first coat had reached its over coating window

The repair was completed within 8 hours, heaters were used to post cure the repair
