## Efficiency and Energy Consumption.

## Life Cycle cost of an Industrial Pump

## Best Efficiency Point

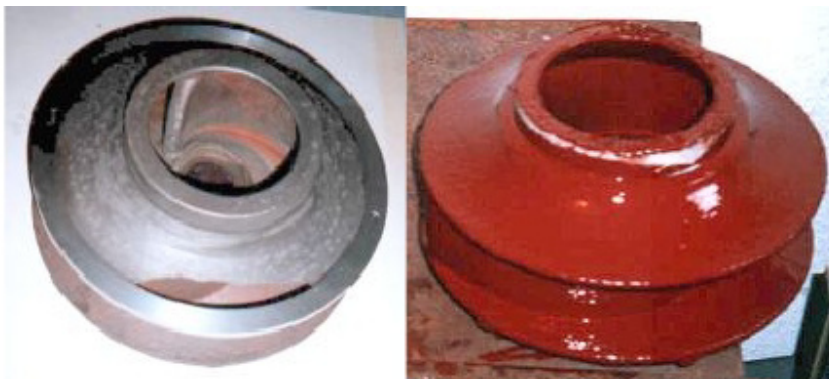
**Before and After Impeller was coated with UPS 210 Super Low Friction Efficiency Coating (Red).**

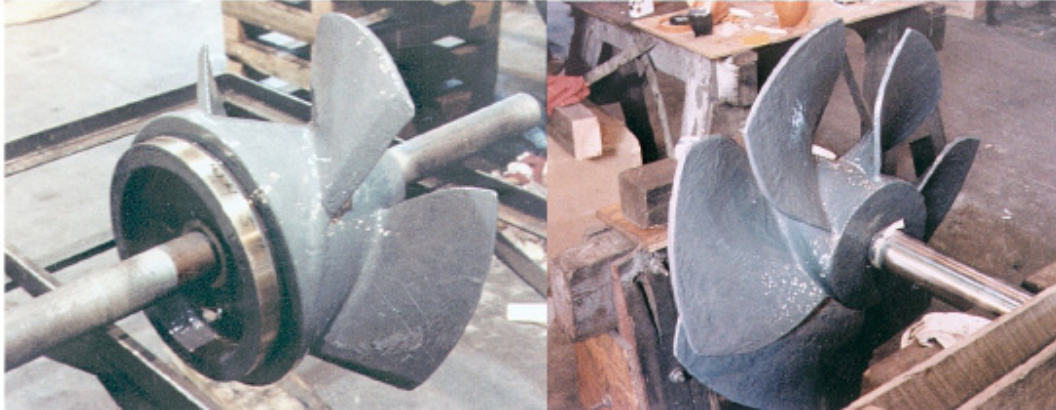
**Pump Impeller blasted and cleaned with Unique Polymers Universal Cleaner and coated with UPS 210 Super Low Friction Efficiency Coating (Grey)**

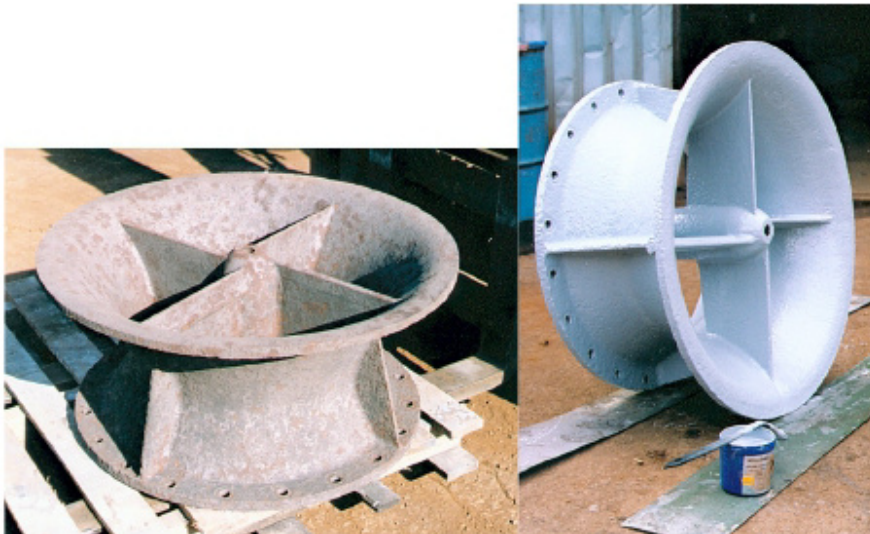
**Pump Impeller blast prepared and coated with UPS 210 Super Low Friction Efficiency Coating.**

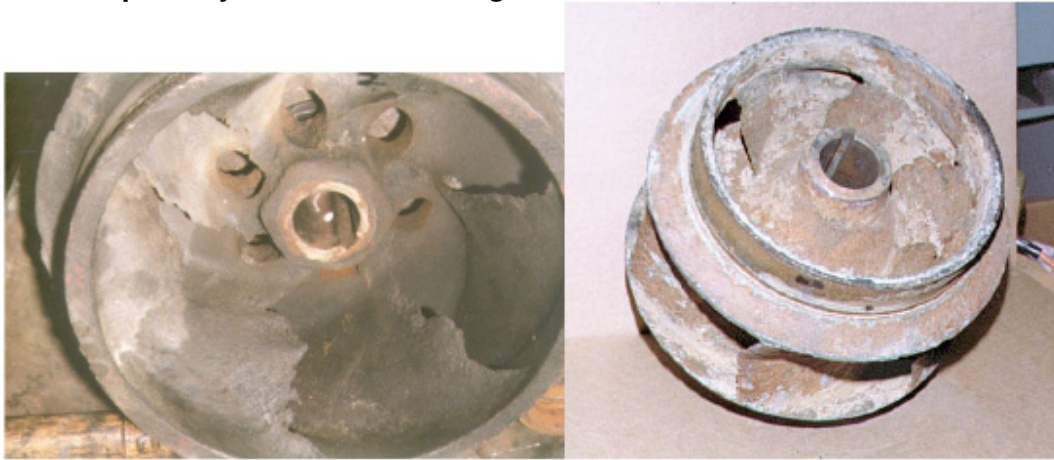
**Pump Impeller ready to blasted**

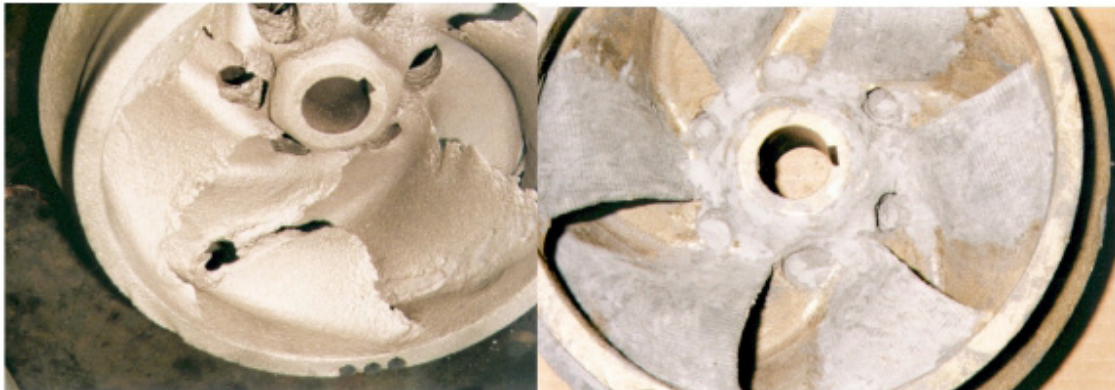
**Pump Impeller blasted and then degreased with Unique Polymers Universal Cleaner. The damaged blades rebuilt with UPS 200 Ceramic Carbide Wearing Compound**

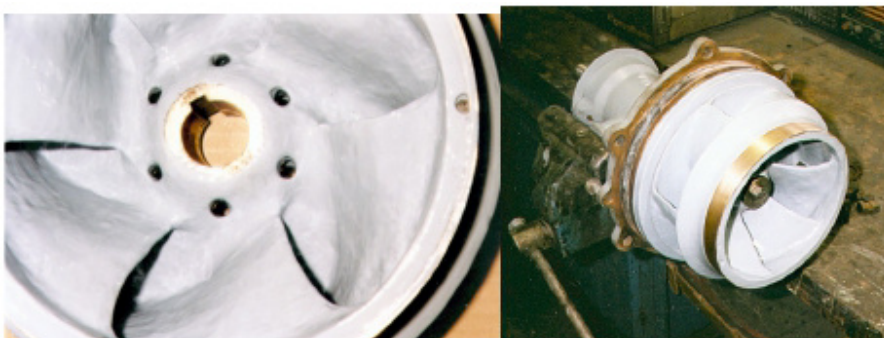
**The Impeller is coated with UPS210 Super Low Friction Efficiency Coating and left to cure.**
