Application Profile

Repair Don't Replace!

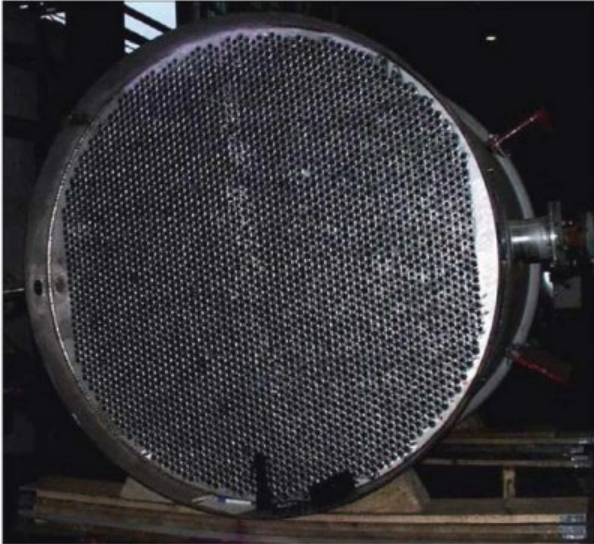
- Many UPS distributors have been awarded the contracts to refurbish damaged heat exchanger end plates.
- In this example the heat exchanger had been in operation for over 3 years and during routine inspection had been found to have been severely corroded in certain areas.
- The UPS Distributor was asked to put forward a recommendation to rebuild and protect the end plates.
- The UPS distributor recommended that the area should be blast cleaned and rebuilt using [UPS105 Metal Repair Paste](#) and then resurfaced with 2 coats of [UPS205 Ceramic Repair Fluid](#).
- Once completed the affected area will be protected for many years from erosion and corrosion

- The affected area was blast cleaned using angled grit to SA2.5 Swedish Standard, 75 micron profile All surfaces were cleaned using an approved UPS surface cleaner
- The uneven surface of the blast cleaned end plate was rebuilt using Unique Polymer Systems [UPS105 Metal Repair Paste](#)

- The product was allowed to cure for 2 hours at 20C using heaters in a tented environment
- Once the product had reached its minimum over coating time 2 coats of [UPS205 Ceramic Repair Fluid](#) were applied at a minimum wet film thickness of 350 microns per coat The repair was completed over two days
