## UPS APPLICATION PROFILE

### Introduction

Unique Polymers has been awarded an ongoing contract to repair and resurface a gas main within a large UK industrial complex. The gases which are produced during the process of salts on site are piped out of the complex through a line of steel pipes.

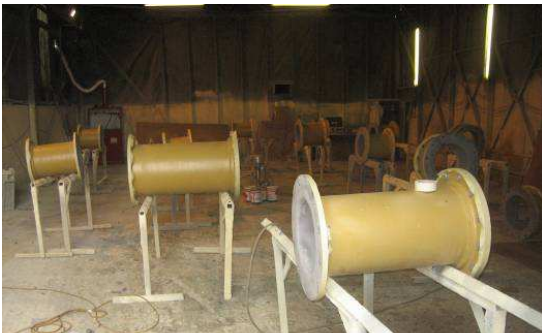
During routine maintenance cracks had been found on the surface of some of the pipe work and the pipe wall had become extremely thin in parts.

UPS recommend the application of 220 High Temperature Repair to the new steel fittings which would have to resist continuous temperatures of 140°C.

The coating work was completed off site at the approved applicator premises.
