## Application Profile

### Repair Don't Replace!

Unique Polymers recently completed a major chemical storage tank refurbishment contract for a major chemical company.

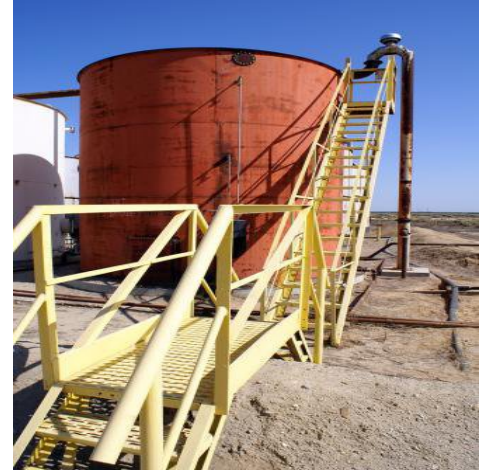
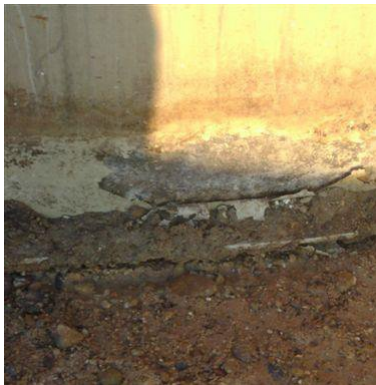
The internal surfaces of the tank had been corroded over 15 years of service and had become dangerously thin towards the base of the tank.

External and internal corrosion meant that steel plates had to be welded onto the surface of the tank before the entire area could be rebuilt and resurfaced.

Unique Polymers recommended that the internal surfaces should be rebuilt where required using [UPS105 Metal Repair Paste](#) and then resurfaced with 2 coats of [UPS205 Ceramic Repair Fluid](#).

- The affected area was blast cleaned using angled grit to SA2.5 Swedish Standard, 75 micron profile All surfaces were cleaned using an approved Unique Polymers surface cleaner
- The uneven surface of the blast cleaned surface was rebuilt using [UPS105 Metal Repair Paste](#)
- The product was allowed to cure overnight at 20C using heaters in the enclosed area
- Once the product had reached its minimum over coating time it was coated with [UPS205 Ceramic Repair Fluid](#) at a minimum wet film thickness of 350 microns

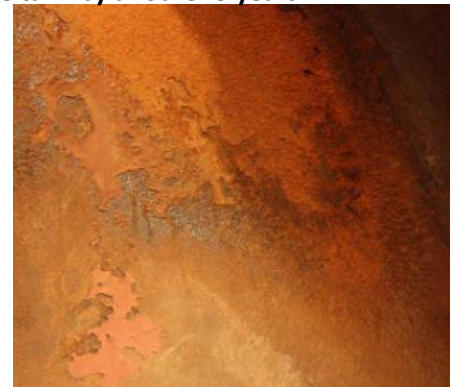
Due to the high viscosity of the materials stored in the tank a highly abrasive resistant coating was put forward as a long term solution. The customer was expecting to extend the life cycle of the tank by another 5 years.
