## UPS APPLICATION REPORT

Unique Polymers has been awarded the contract to refurbish 15 hot air fans in a Salt processing factory. The environment of the plant ensures that carbon steel surface need to be protected at all times.

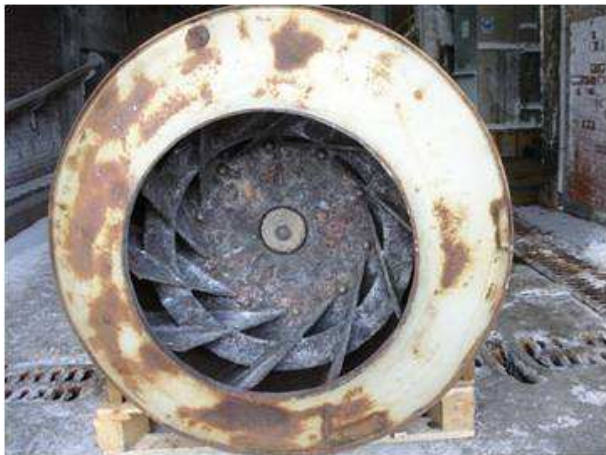
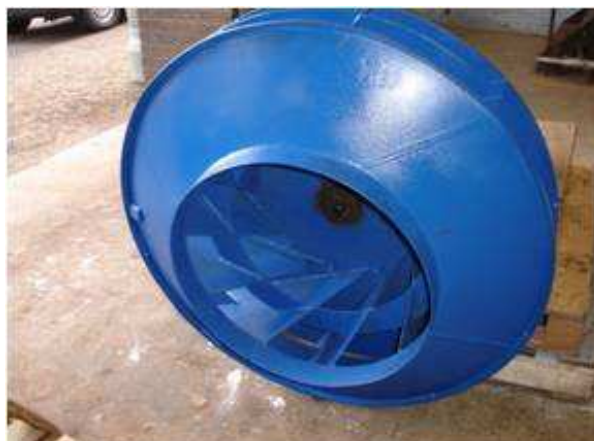
The fans are used in a drying process and over a period of time salt spray builds up on the surface of the fan.

UPS recommended the application of UPS210 Super Flow Ceramic Repair Fluid to the surface of the fan, the material offers a smooth flow efficiency finish to metal surfaces.

The fan was abrasive blast cleaned and the material was applied in two coats over all areas of the fan.

The affected area was cleaned using abrasive blast cleaning (angled grit), to SA2.5 50-60 micron profile

The surface of the fan was degreased using MEK

The first coat of 210 Super Flow Ceramic Repair Fluid was applied to the prepared surface

The coating was allowed to cure for 6 hours prior to the application of the 2<sup>nd</sup> coat

Once touch dry the fans were then post cured using heaters
